ATTENTION: GPS Speedometer Recall - Hot Start resistor fix

For Immediate Release - January 11, 2013 - Speedhut, Inc. of Orem, Utah is issuing the following consumer repair to be performed on all **4" GPS speedometers purchased from October 1, 2012 to January 10, 2013.**

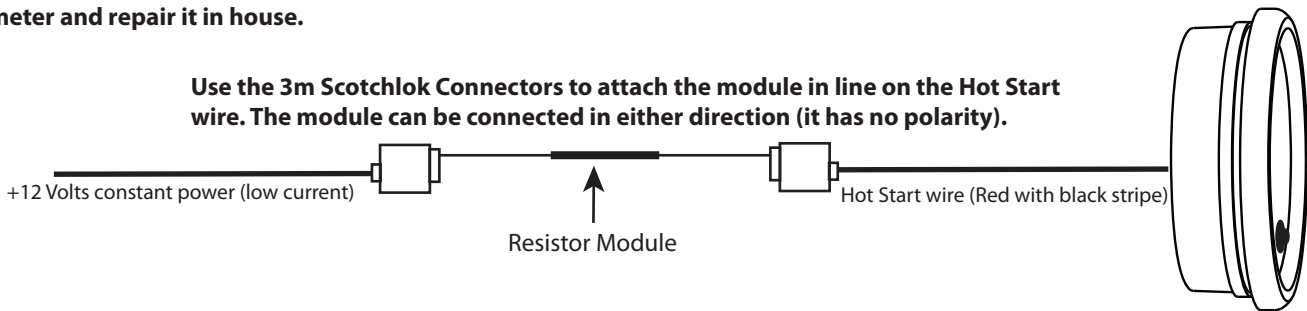
4" GPS speedometers manufactured in the noted date range contain an incorrect electrical component installed on the unit's internal circuit board. The provided resistor module should be placed in-line with the Speedometer's "Hot Start" wire (Red wire with black stripe). **Failure to install this module prior to connecting the "Hot Start" wire to a voltage source will result in permanent damage to the GPS speedometer.**

If you do not feel comfortable performing the resistor module installation please contact us and we will be happy to issue an RMA for your speedometer and repair it in house.
